## **FOLLY BEACH GROIN REHABILITATION 2<sup>nd</sup> ANNUAL MONITORING REPORT**

**July 2021**

**Permit # 2017-00730**

Elko Coastal Consulting, Inc.  
P.O. Box 1451, Folly Beach, SC 29439

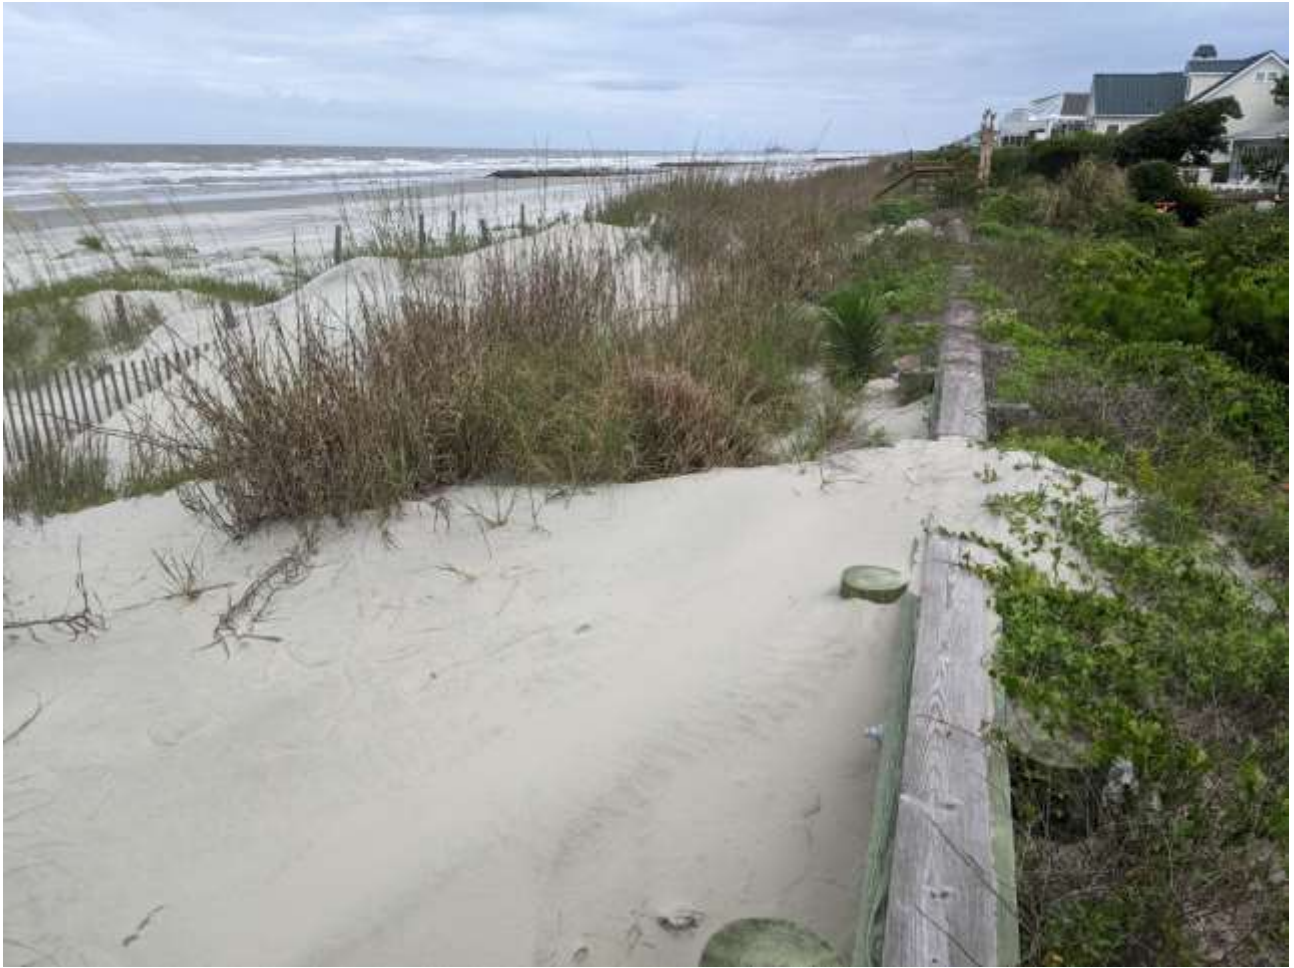
Figure 4. Photograph of the dune system at 11th St. E, looking west. Taken on June 22, 2021.

Dune growth was measured and observed throughout the rehabilitated groin field (Appendix A). The downdrift profile 2843 gained several feet of dune elevation over the last three years (Figure 3). As noted above, most of the beach within the rehabilitated groin field did not have a dune prior to this project. The beach eroded to the seawalls between renourishment events. In June 2021, a remarkable amount of dune growth was observed along the entire rehabilitated groin field project area (Figure 4).

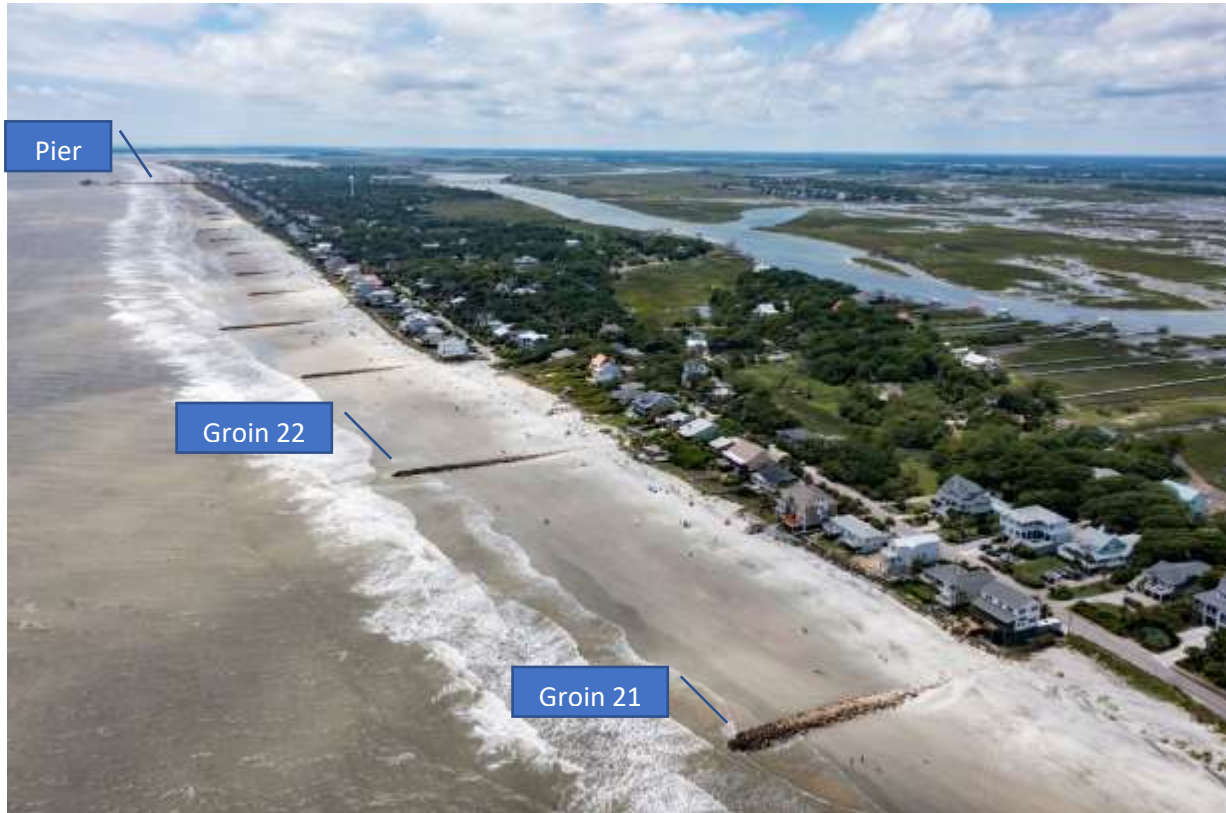
*Figure 1. Aerial photo of the rehabilitated groin field in June 2021 looking southwest at groins #21 (near Washout) to #29 (between 8th and 9th St. E.). Note the dune vegetation and wide backbeach within the dune field.*

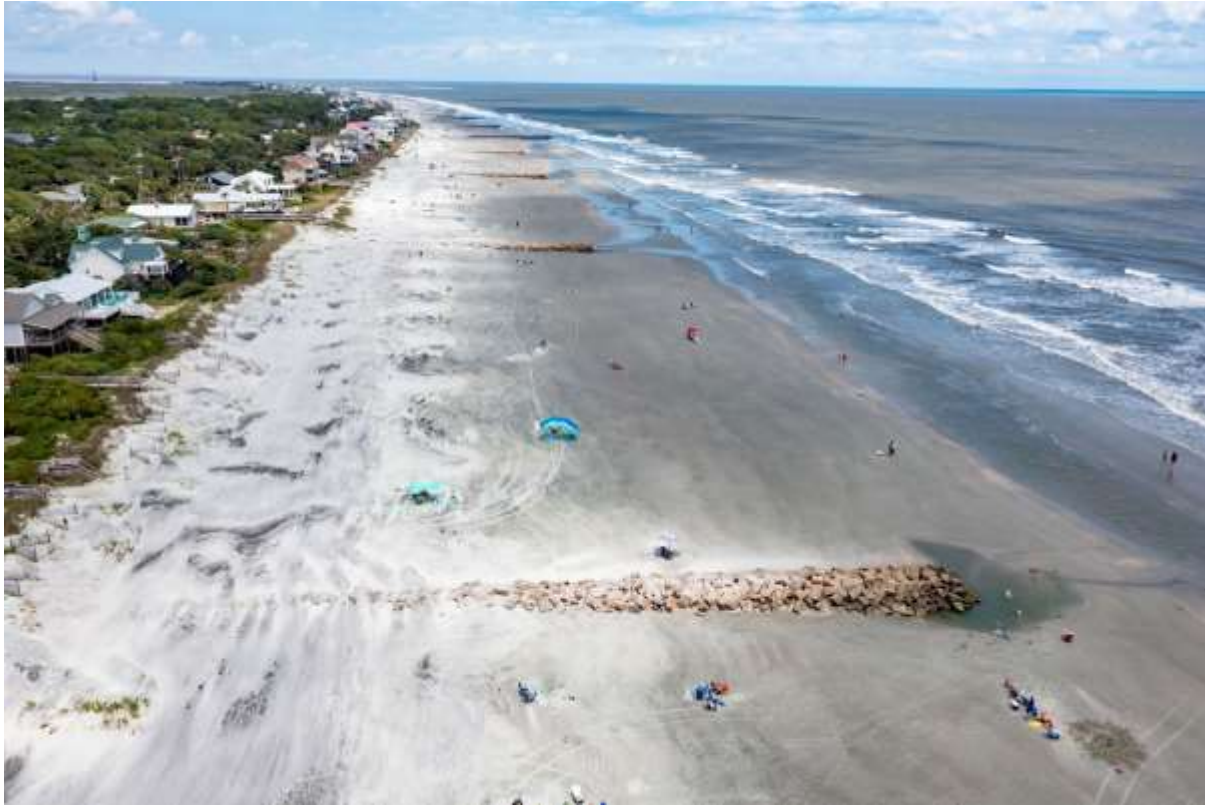
Figure 2. Aerial photo of the rehabilitated groin field in June 2021 looking northeast at groins #28 (near 9th St. E.) to #21 (near Washout). Note the advancing dune field, sand fencing and wide backbeach.

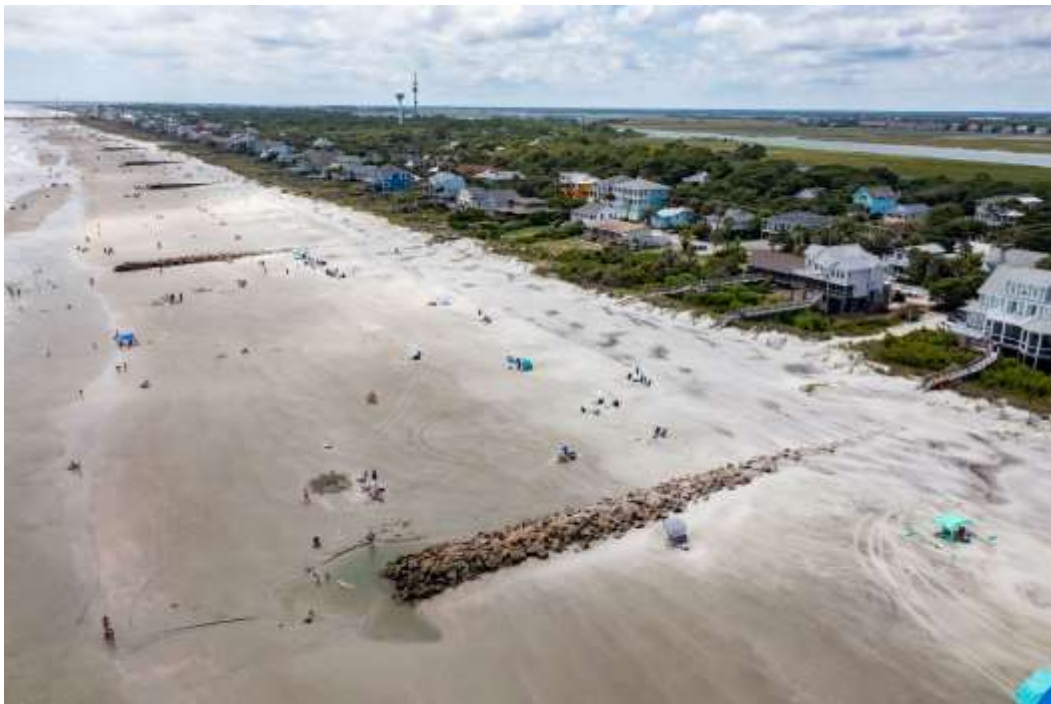
Figure 3. Oblique aerial photo of the west end of the rehabilitated groin field in June 2021 looking south at groins #28 and #29 (between 8th and 9th St. E.). The concrete cap groins that were rehabilitated by the Army Corps in 1993 are visible in the background east of the pier. No downdrift impacts were observed.

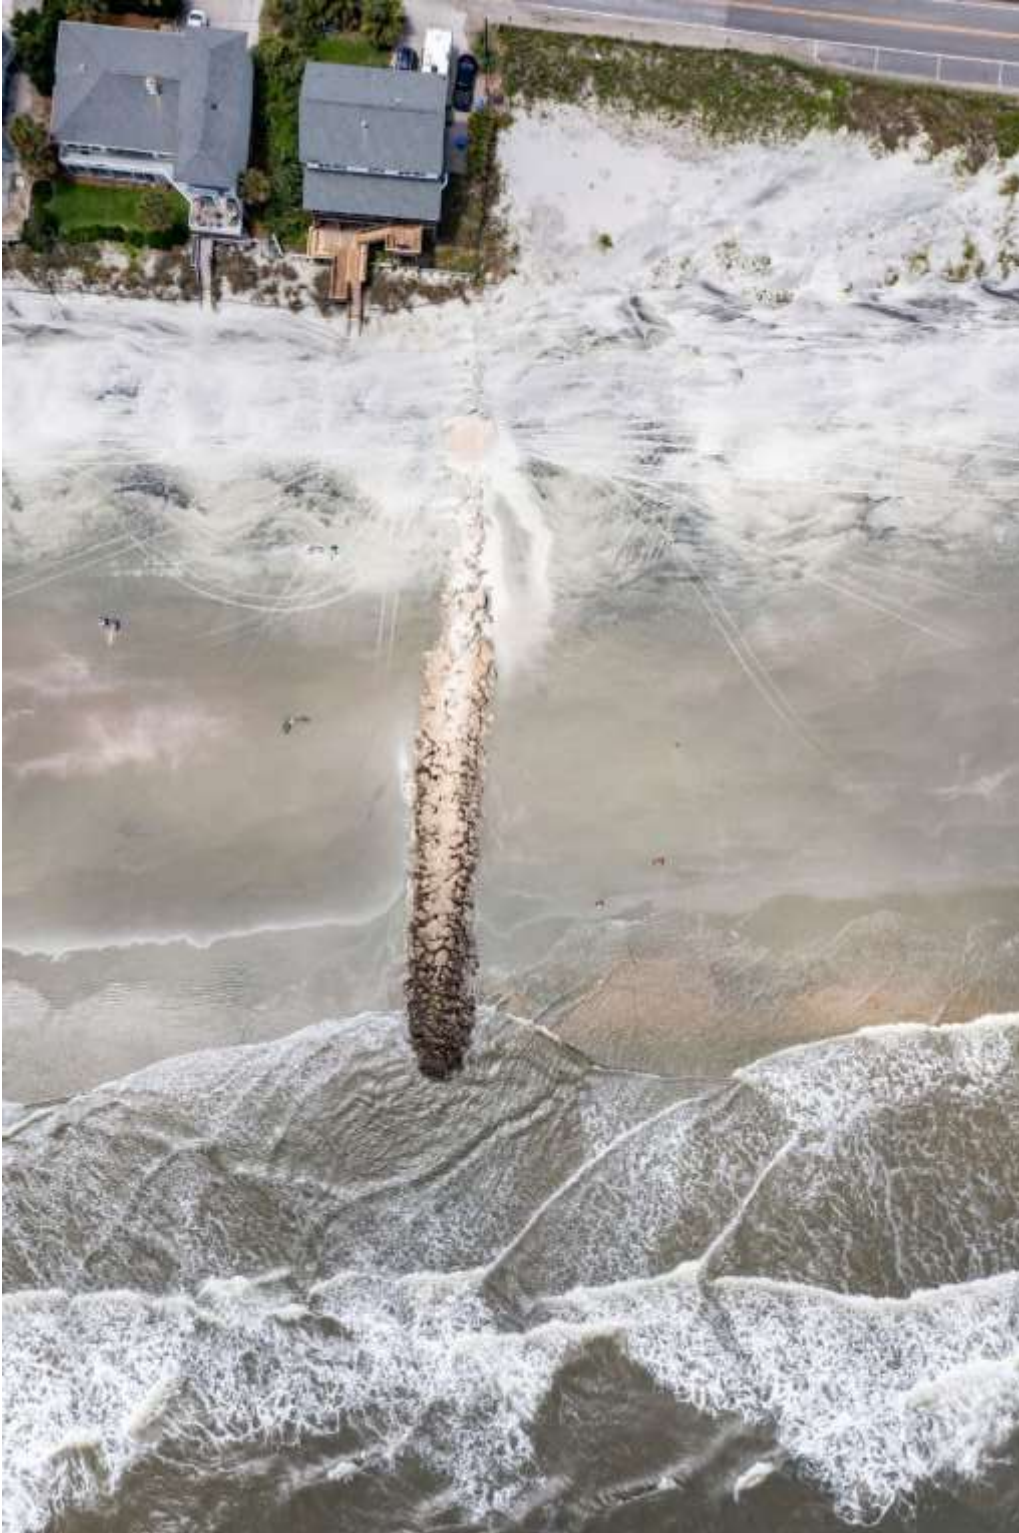
*Figure 4. Groin 21 in June 2021 This groin is closest to the Washout by profile 2863.*

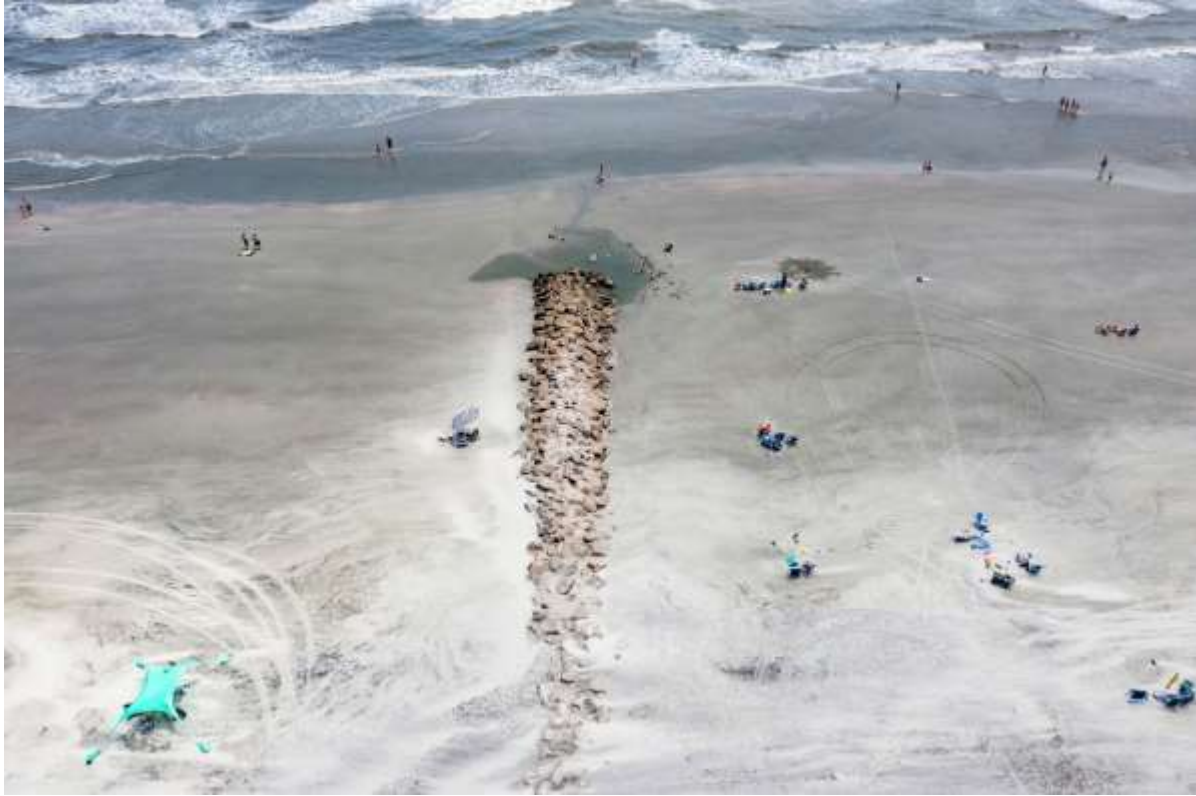
*Figure 12. Groin 29 in June 2021. This is the most downdrift (westernmost) groin by profile 2843.*
