Folly Beach 4-Yr Post-Nourishment Monitoring Report

2022 FOLLY BEACH 4-YR POST-NOURISHMENT MONITORING REPORT

The City of Folly Beach, SC

Elko Coastal Consulting, Inc.

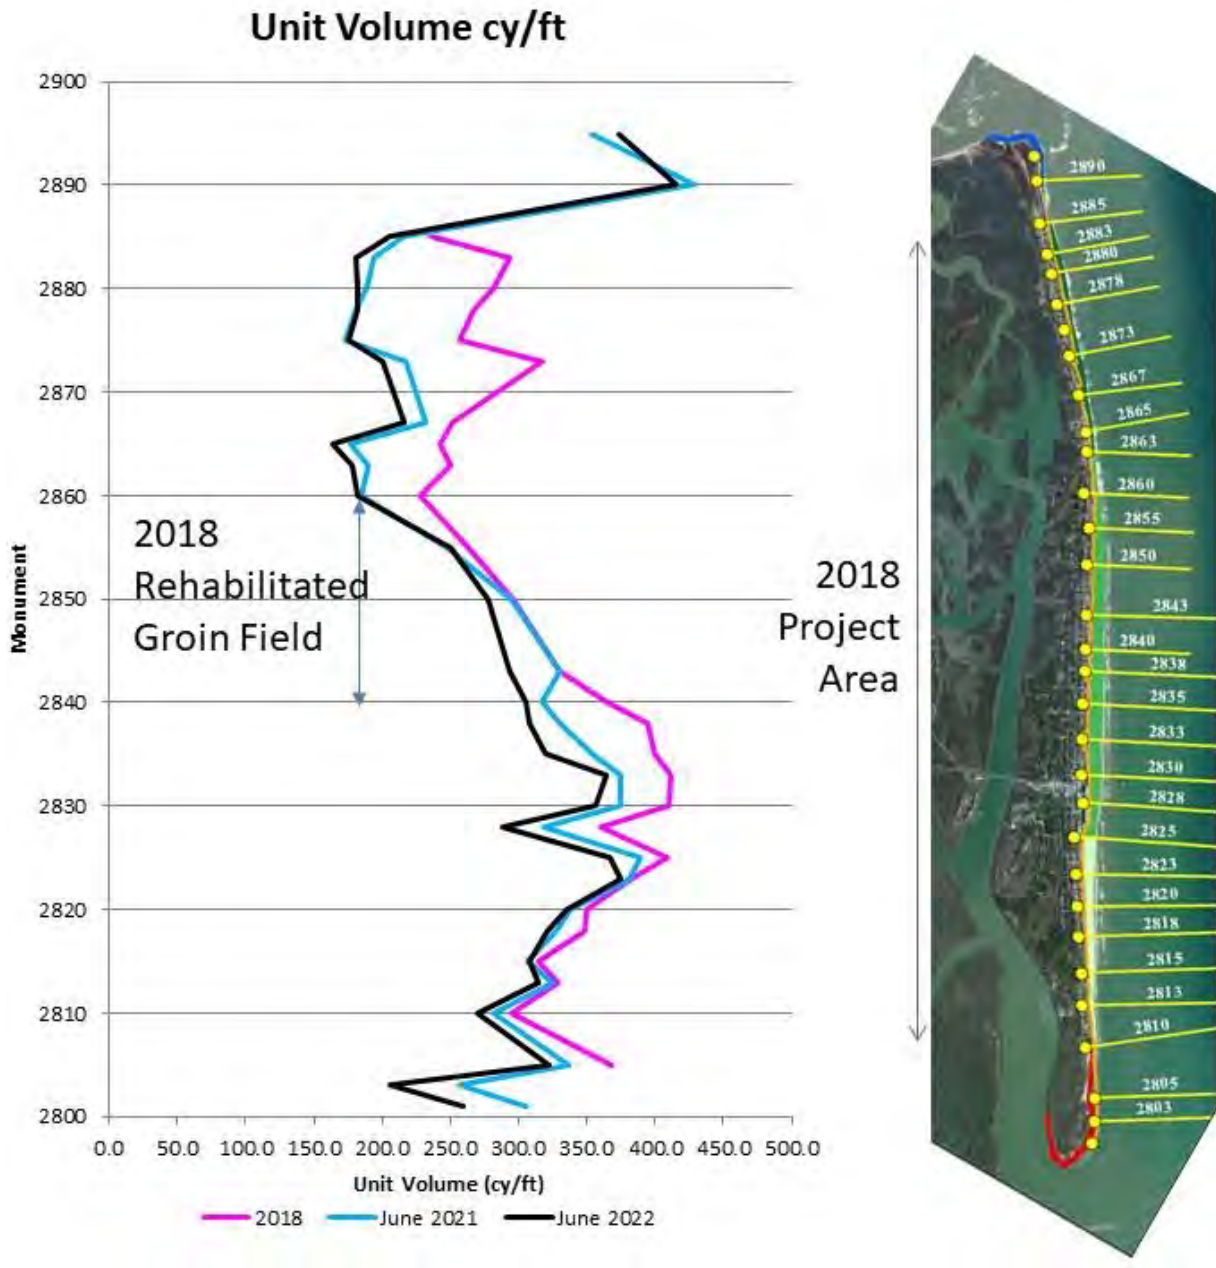
Unit volume changes alongshore from post-construction in 2018 to June 2022 are displayed in Figure 8. Recall that volume was calculated from the PEL out to -14 ft NGVD (Federal project limits only, not private property).

Volume change during the last year was relatively stable along the west end of the project area from 2810 northwest to monument 2825 (3rd St. W.) and northeast of 2855 (11th St. E.). The southwestern portion, and the area downdrift of, the rehabilitated groin field lost the most volume (Figure 8). This same trend is shown in Appendix A.

Figure 8. Unit volume measured immediately after construction in 2018 and during the third- and fourth-year monitoring surveys (June 2021 and 2022).

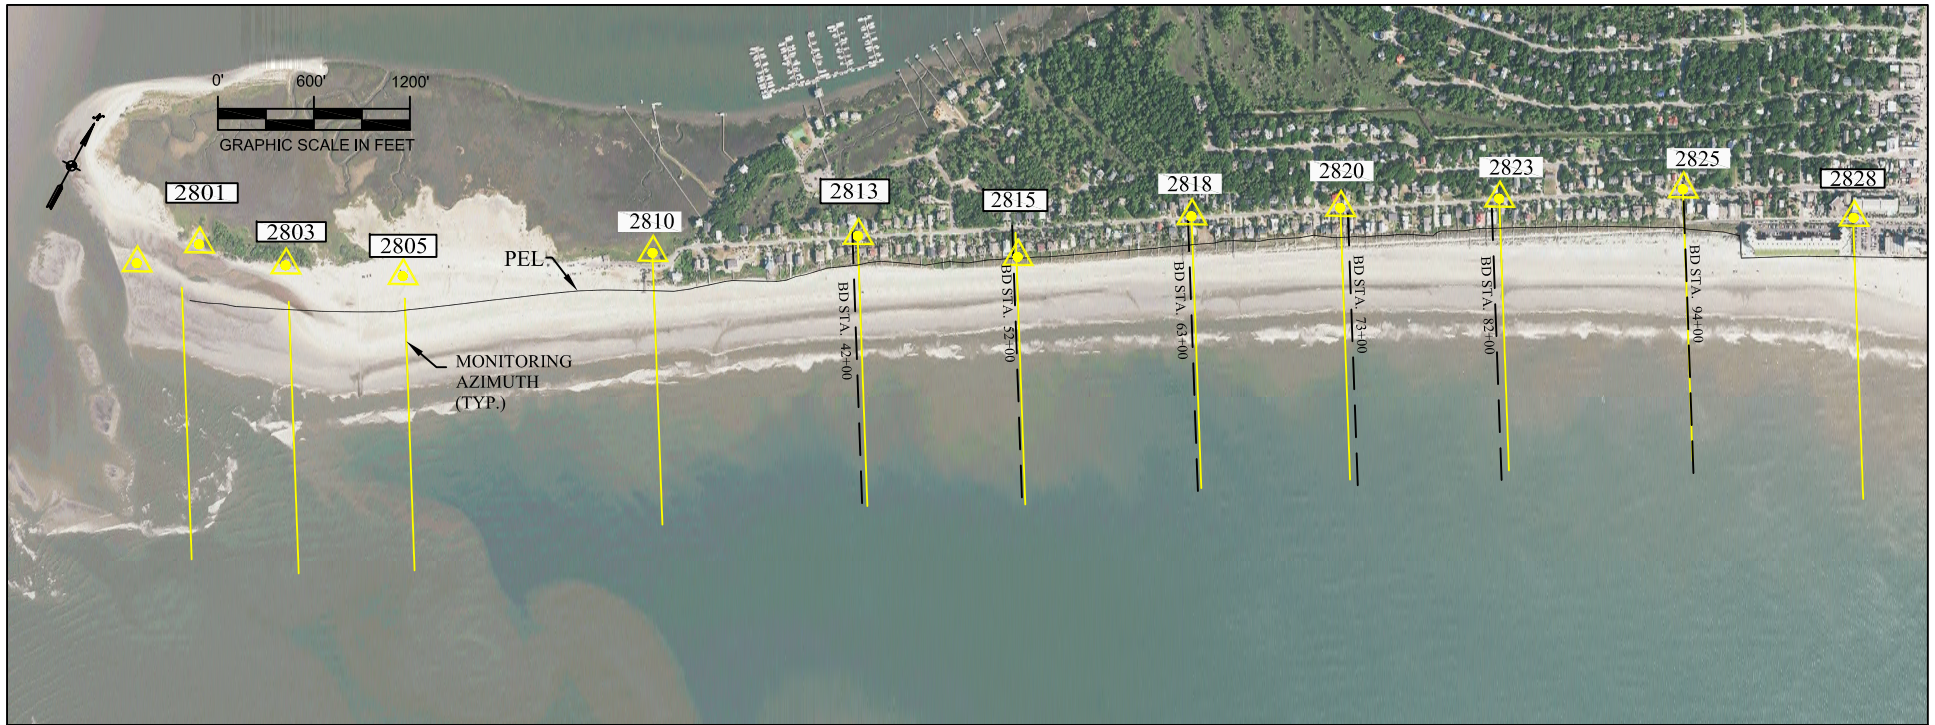
TITLE:
CITY OF FOLLY BEACH
4-YR (2022) POST CON. MONITORING
8-FT BERM & VOLUMETRIC CHANGE
SCCC 2801 THRU 2828

NOTE: RENOURISHMENT IS TO BE INITIATED WHEN THE 8-FT (NAVD88) DESIGN BERM IS LESS THAN 15-FT WIDE FOR 25% OF PROJECT AREA.

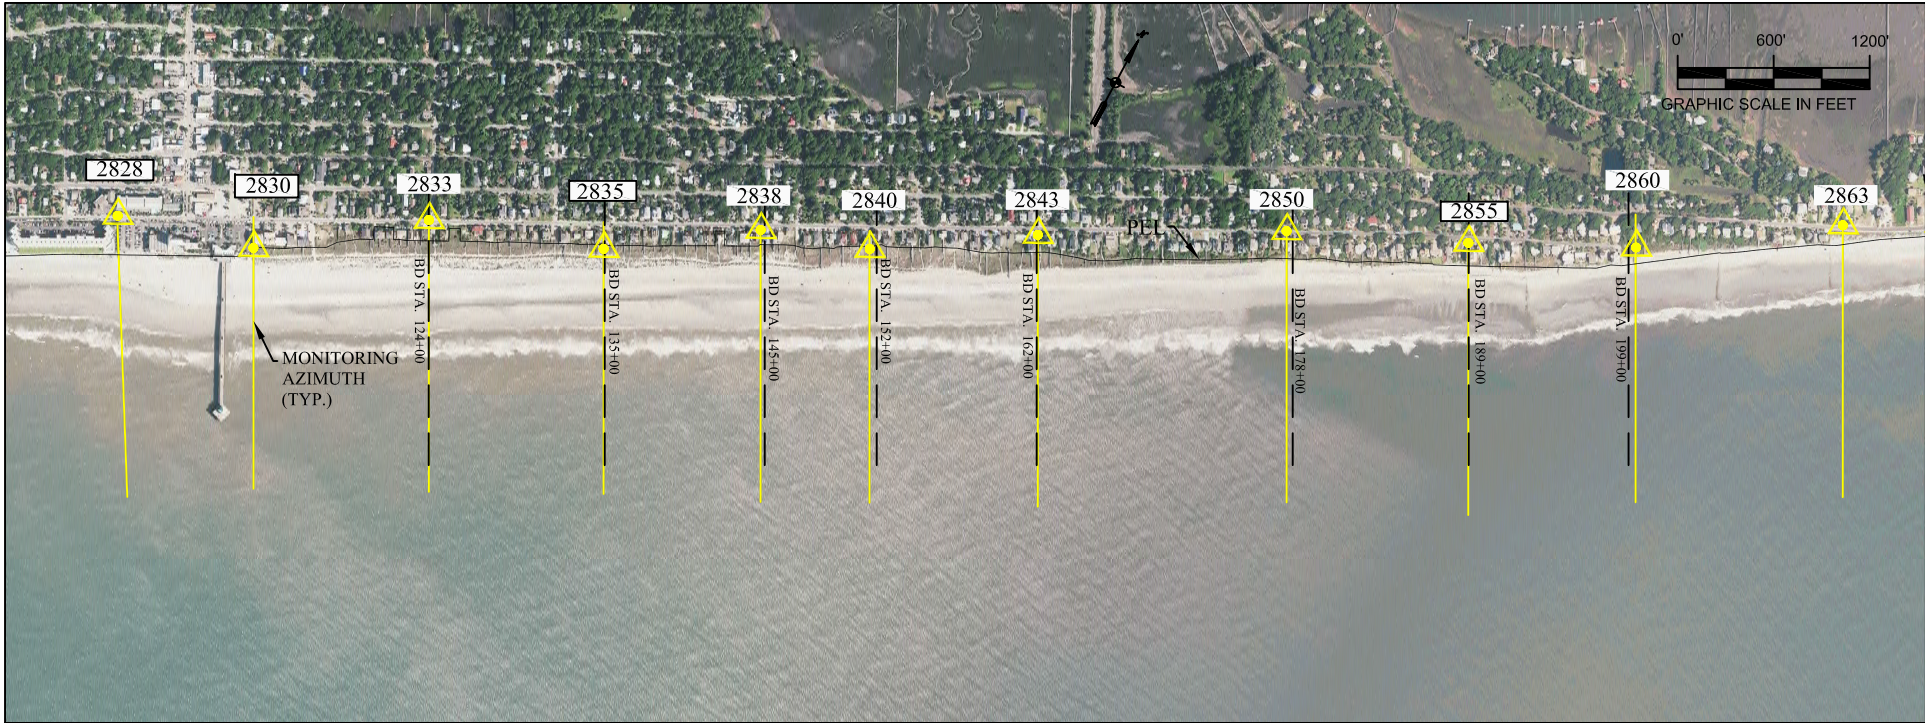
5. POST CONSTRUCTION (2018) MONITORING SURVEY CONDUCTED BY GBA (AUG - NOV 2018)
6. PRE-CONSTRUCTION (BD) SURVEY CONDUCTED BY GBA ON JULY 2018.
7. SURVEYS CAN ONLY BE CONSIDERED AS INDICATING THE GENERAL CONDITIONS EXISTING AT THAT TIME.

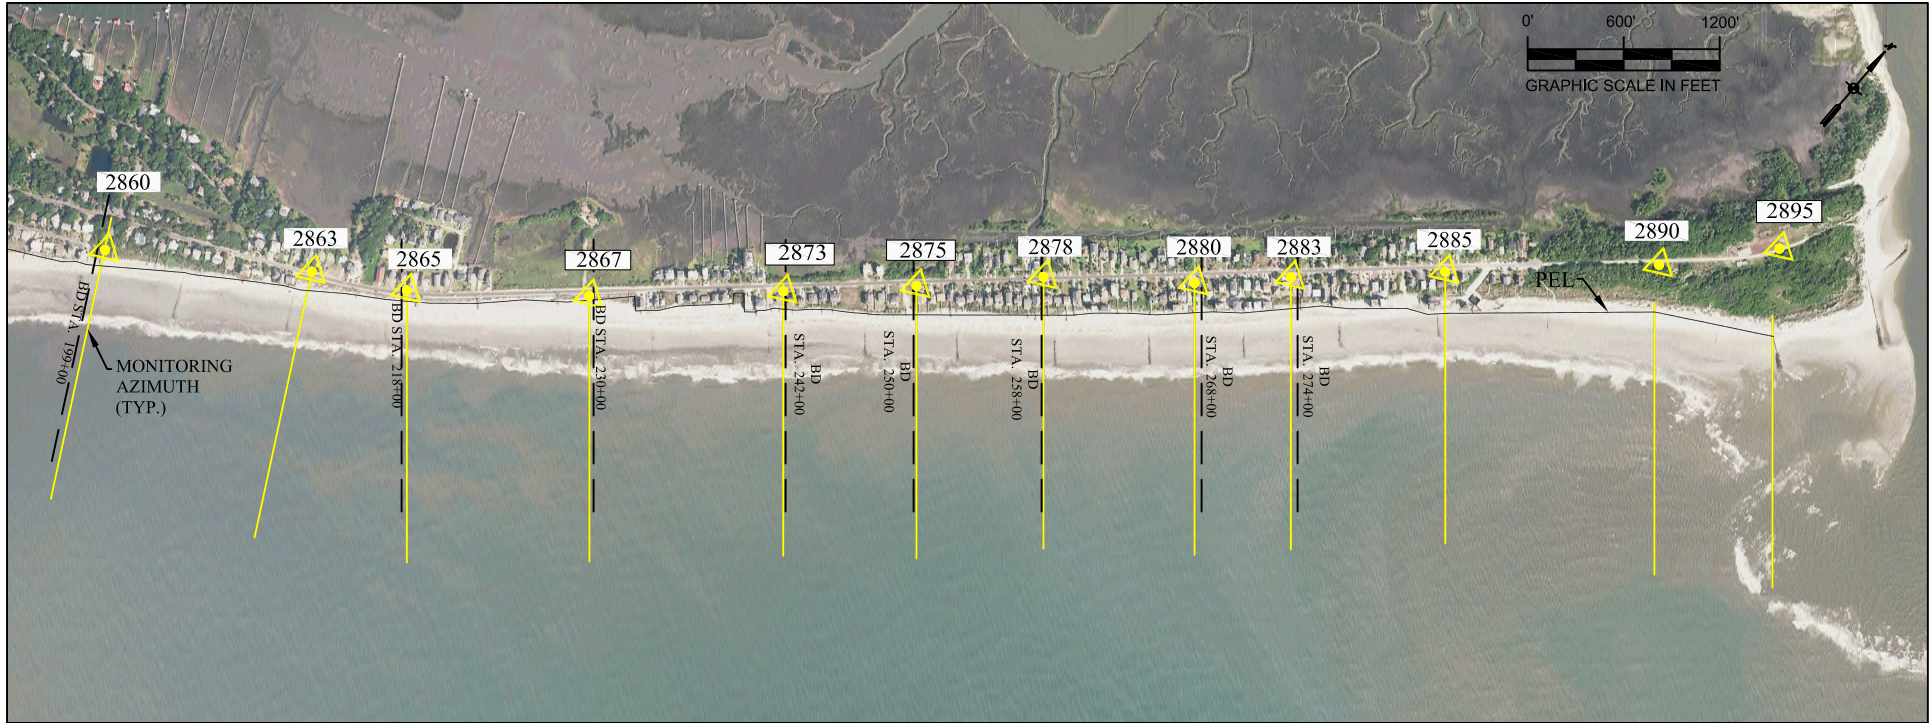
TITLE:
CITY OF FOLLY BEACH
4-YR (2022) POST CON. MONITORING
8-FT BERM & VOLUMETRIC CHANGE
SCCC 2863B THRU 2895

8-FT DESIGN BERM WIDTH SEAWARD OF PEL

NOTE: RENOURISHMENT IS TO BE INITIATED WHEN THE 8-FT (NAVD88) DESIGN BERM IS LESS THAN 15-FT WIDE FOR 25% OF PROJECT AREA.
