# Folly Beach Island-Wide Groin Rehabilitation Master Plan

City of Folly Beach, South Carolina

May 10, 2022

## **Appendix A – Groin Conditions Photo Log**

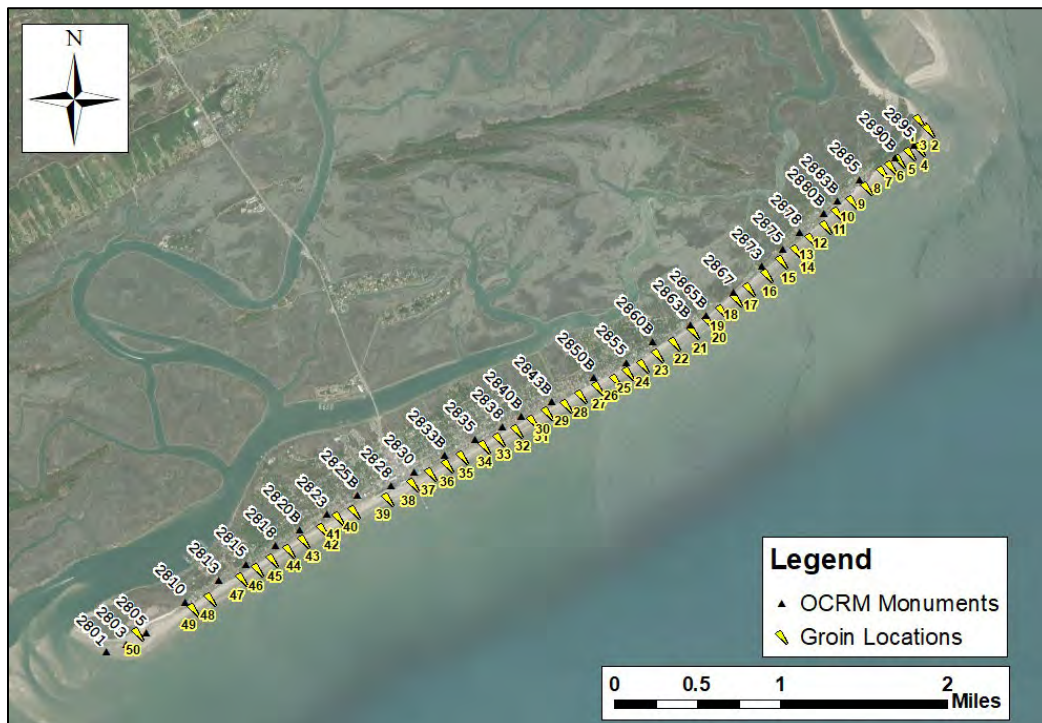
**Figure 1. Overview of Folly Beach Groin Locations and Numbering. SCDHEC-OCRM Beach Survey Monument Stations also shown for reference.**

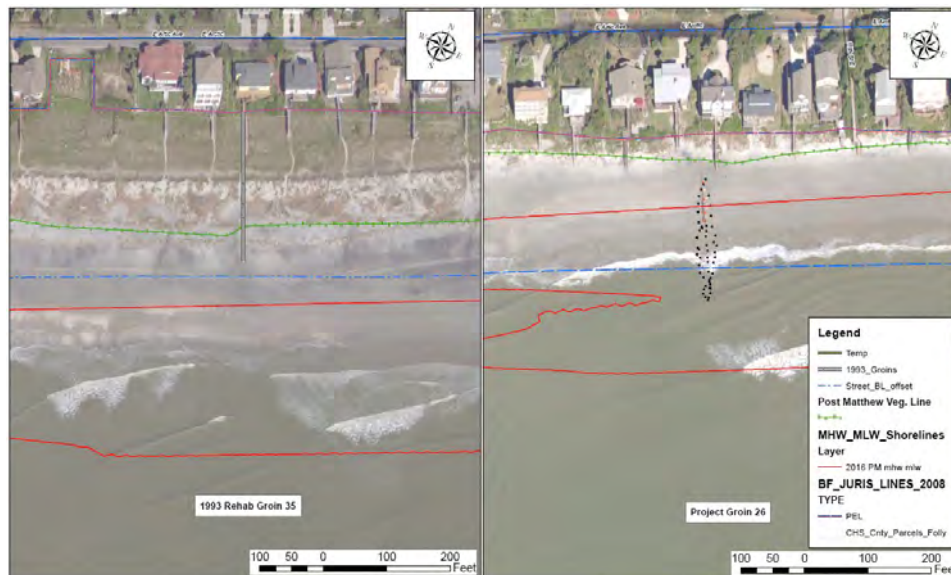
**Figure 5. Comparison of beach health at functional (left) and poorly functional (right) groin systems. Note much healthier and wider dune system on the left image.**

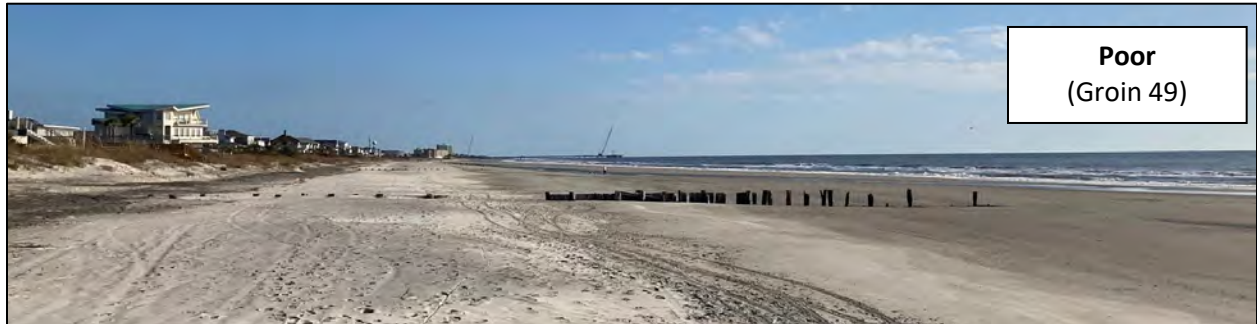
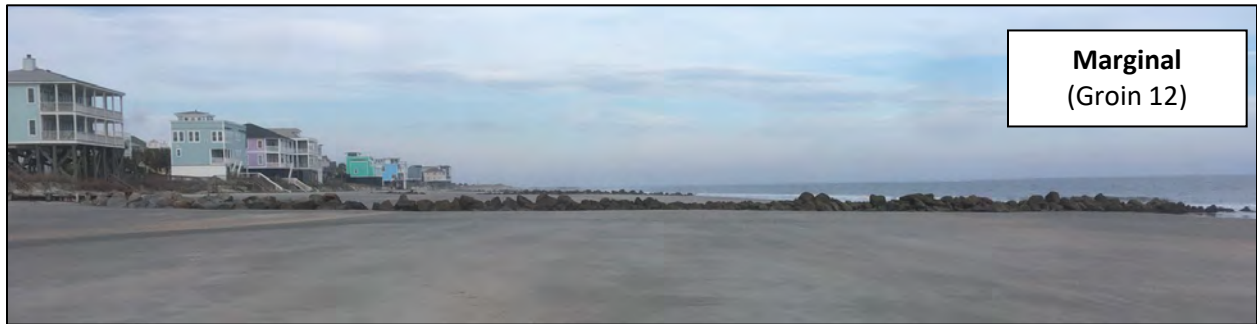
- Functionality - The condition assessment was performed using both site ground and drone aerial observations and measurements of the existing groins. The “functionality” of each groin was categorized as “good”, “marginal”, or “poor” by visually assessing the exposed groin elements (rock, timber, sheetpile, concrete), measuring the exposed heights above grade, measuring the linear gaps between existing exposed sections along each groin (if/where gaps are present due to damaged and/or buried groin sections), to qualitatively evaluate the overall current functionality (i.e., to promote accretion and shoreline stabilization). Figure 6 presents photographs of representative groins of the three condition classification types to illustrate the differences.

The rehabilitated groins, including the 1993 groins, are in overall good condition (although some maintenance of these sheetpile structures will be required in the future). The original groins are in poor or marginal condition, with the majority being in poor condition.

**Figure 6. Folly Beach Existing Groin Condition Photographs. Representative poor, marginal, and good condition groins shown.**

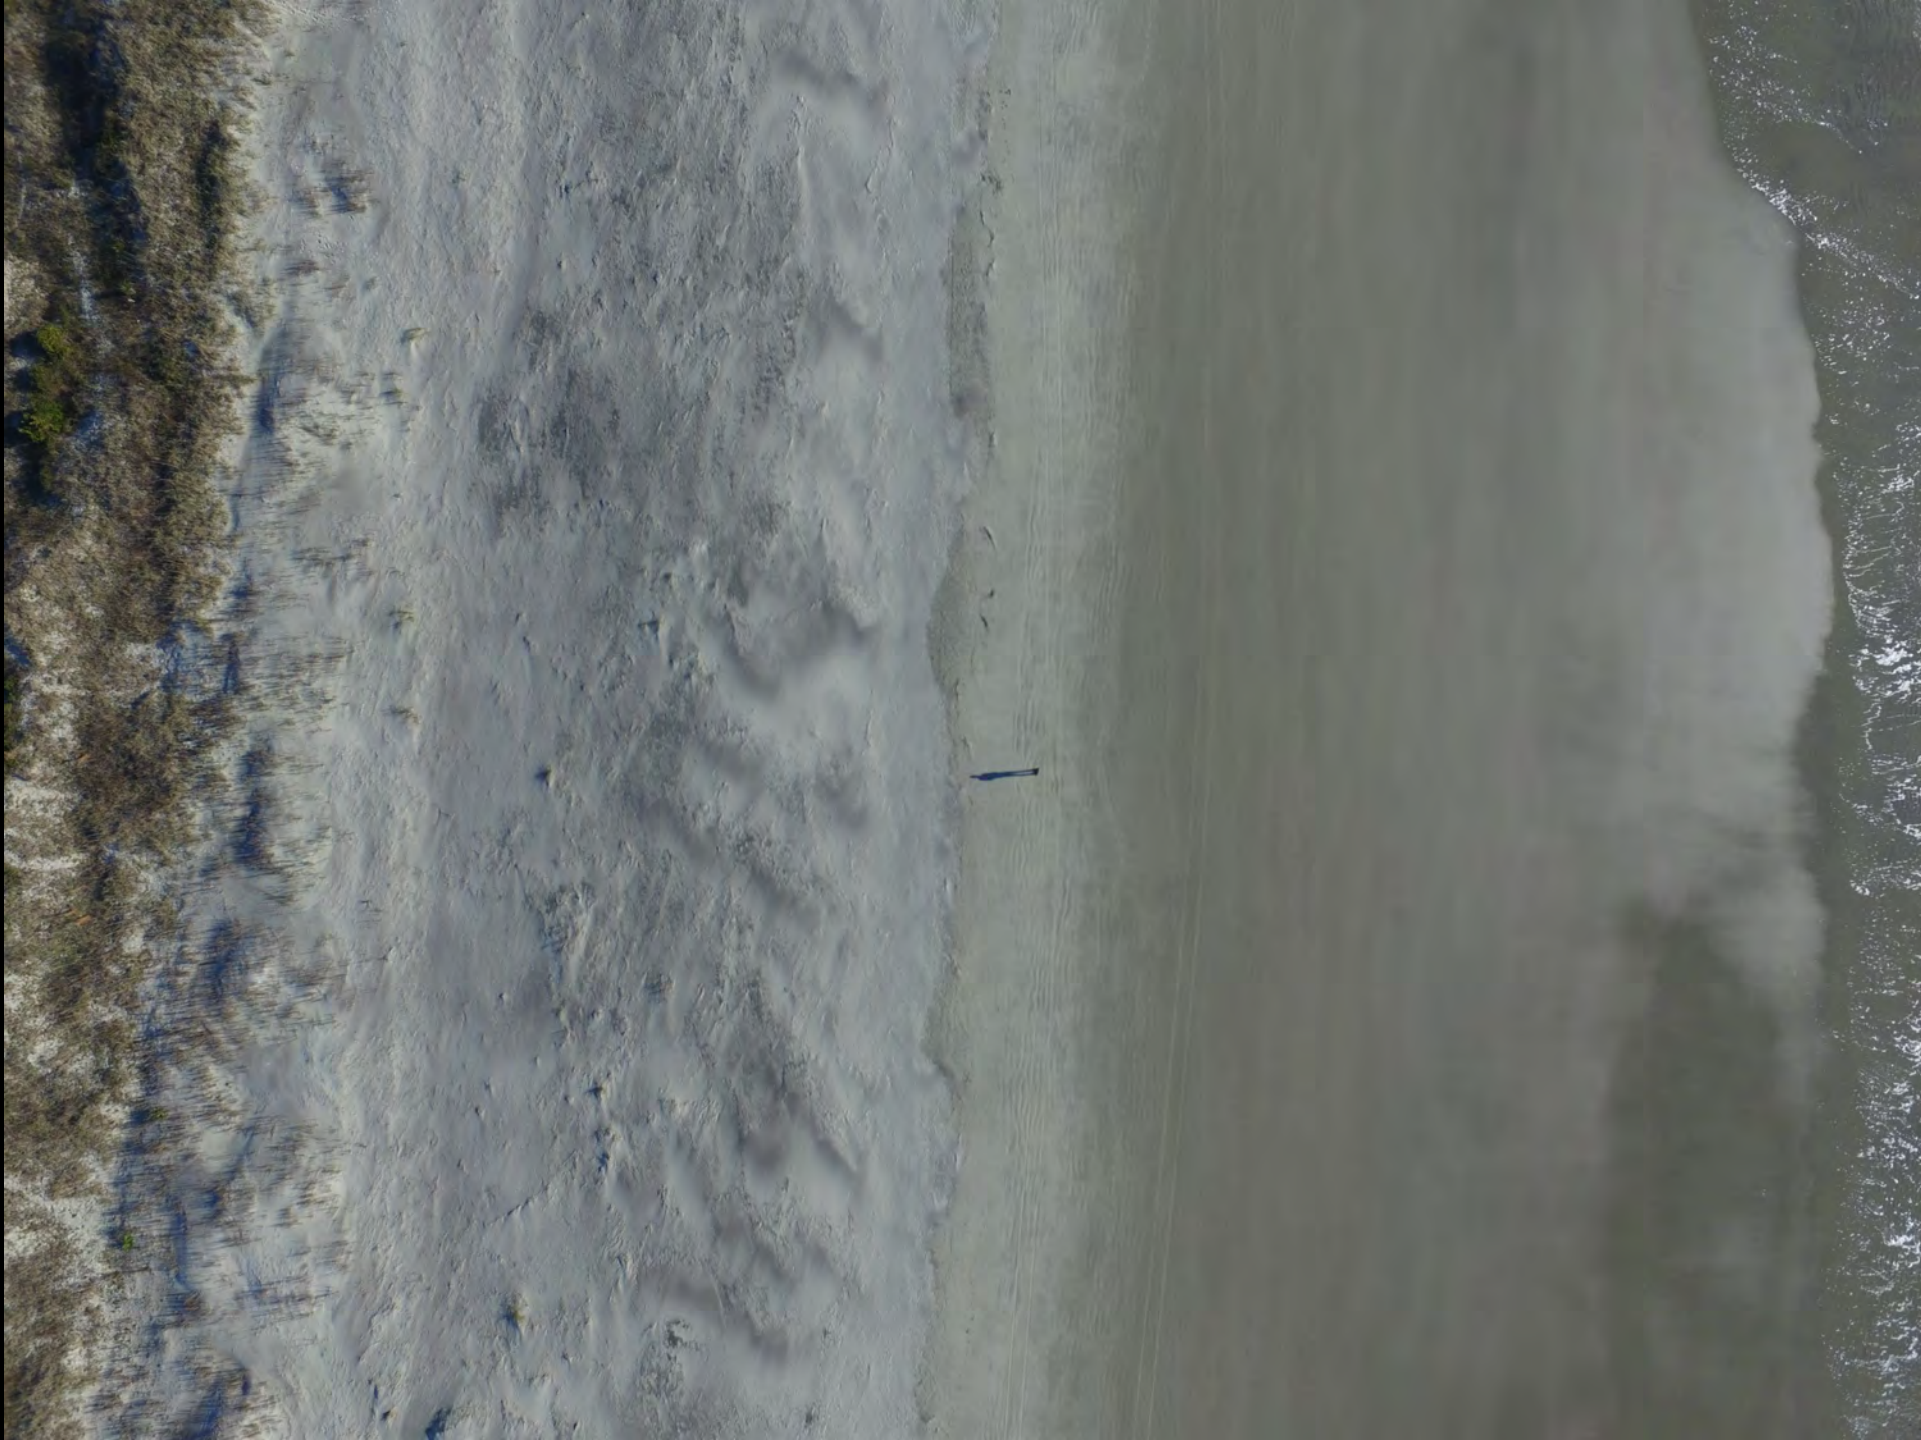
Groin 6 (Buried)

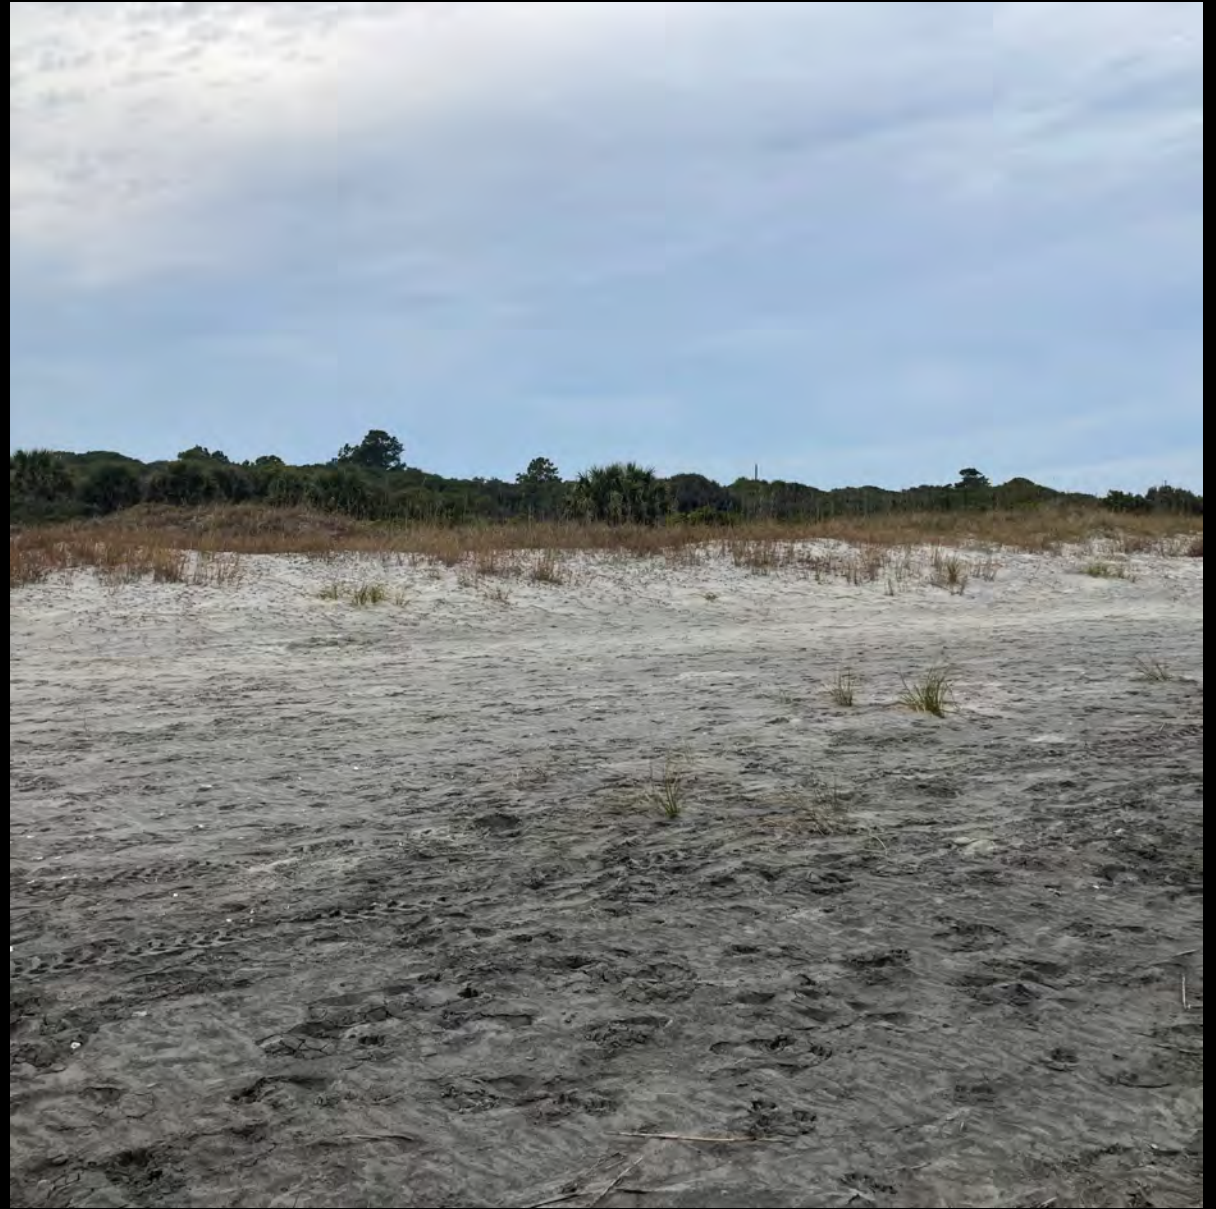
Groin 6 (Buried)

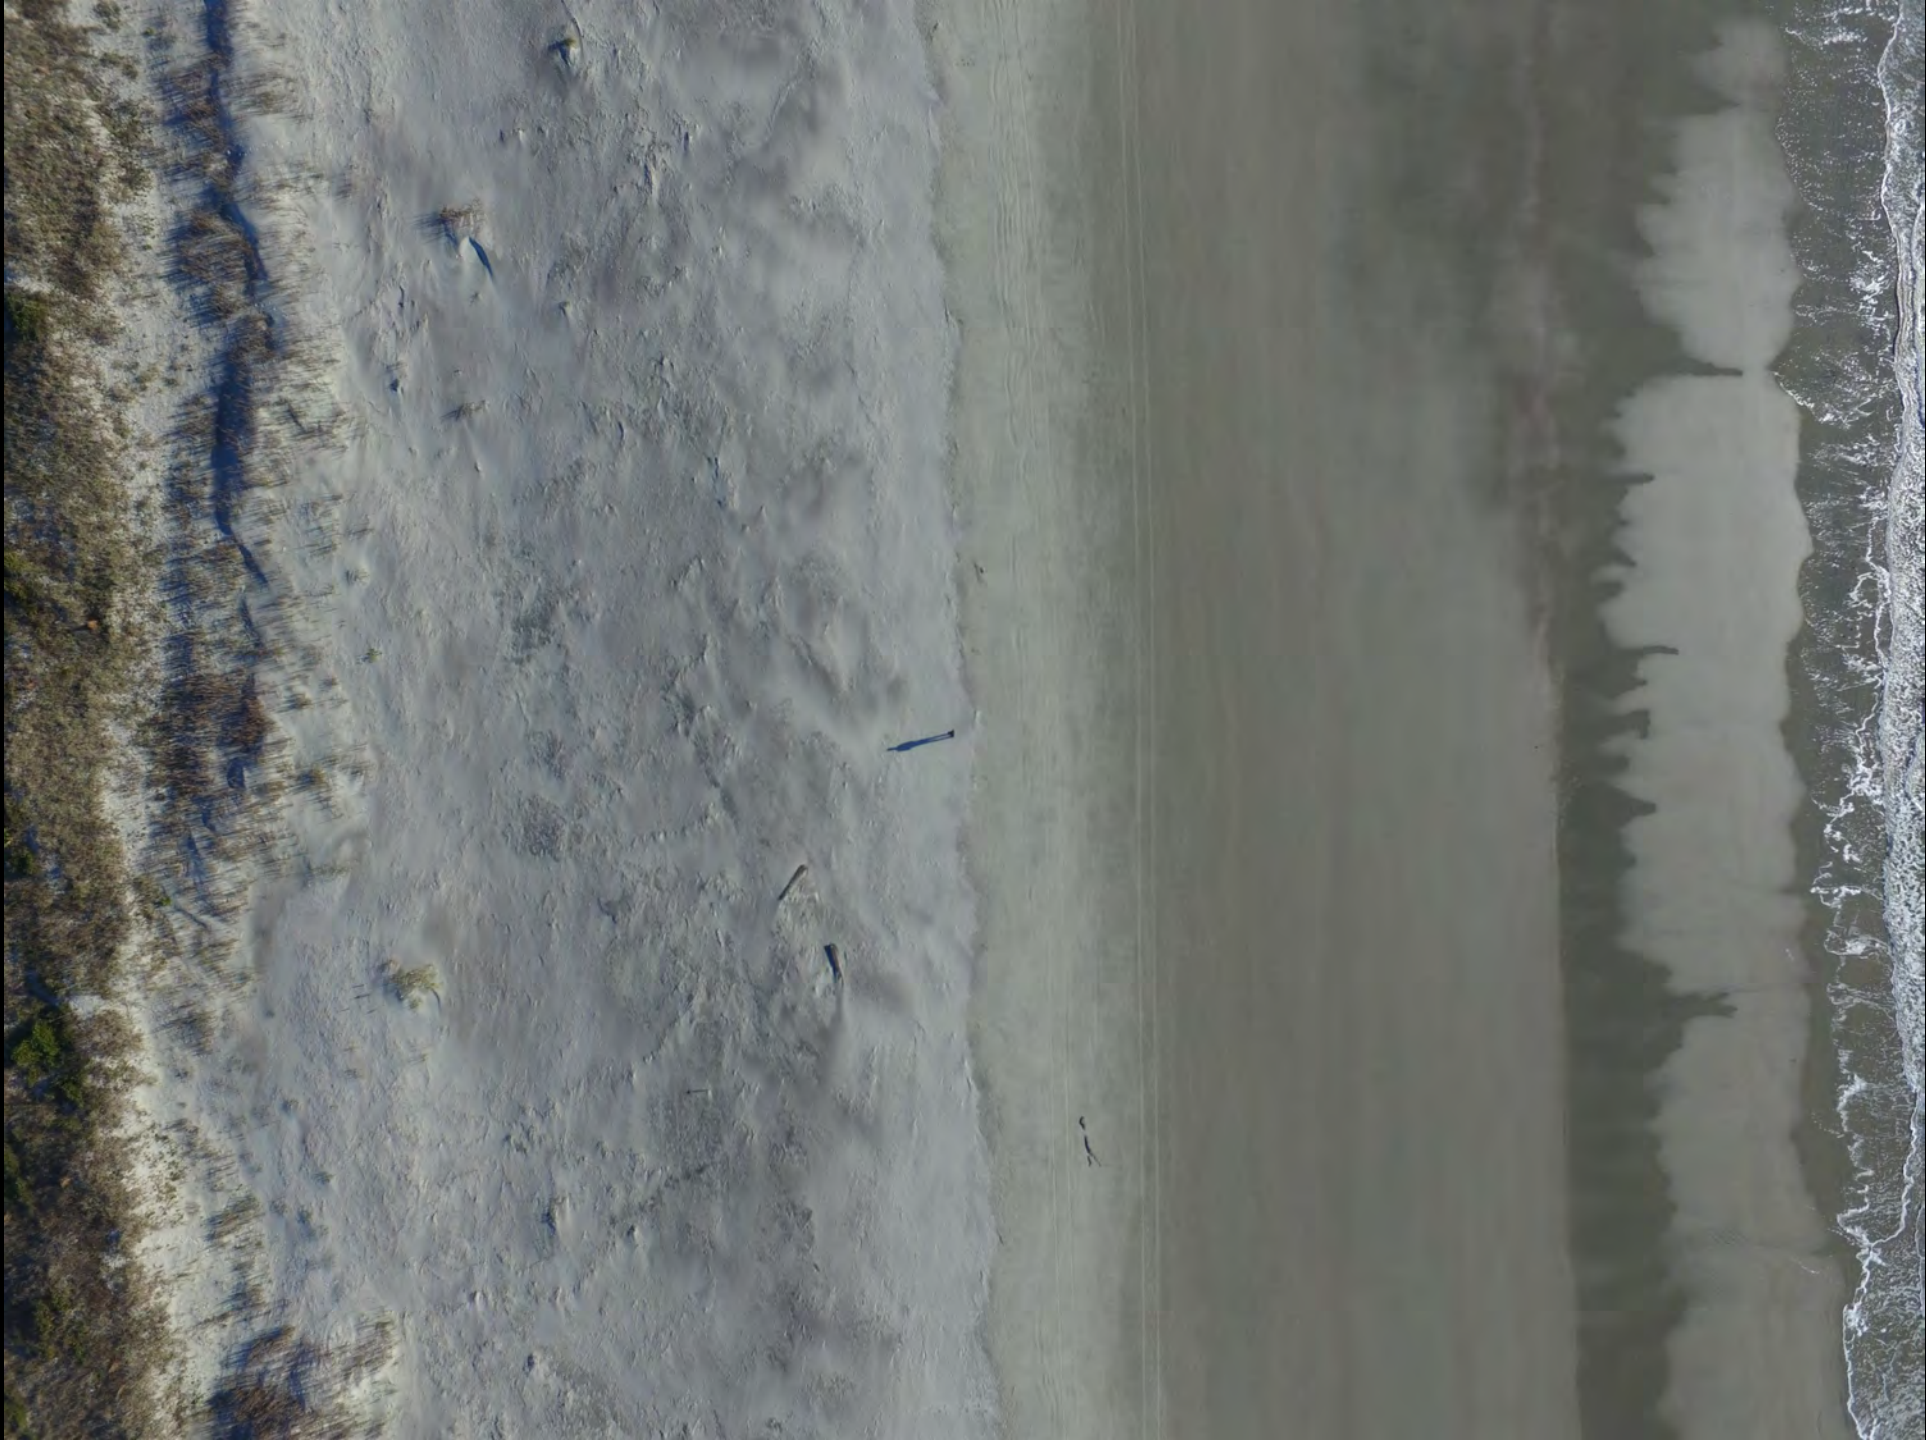
Groin 7 (Buried)

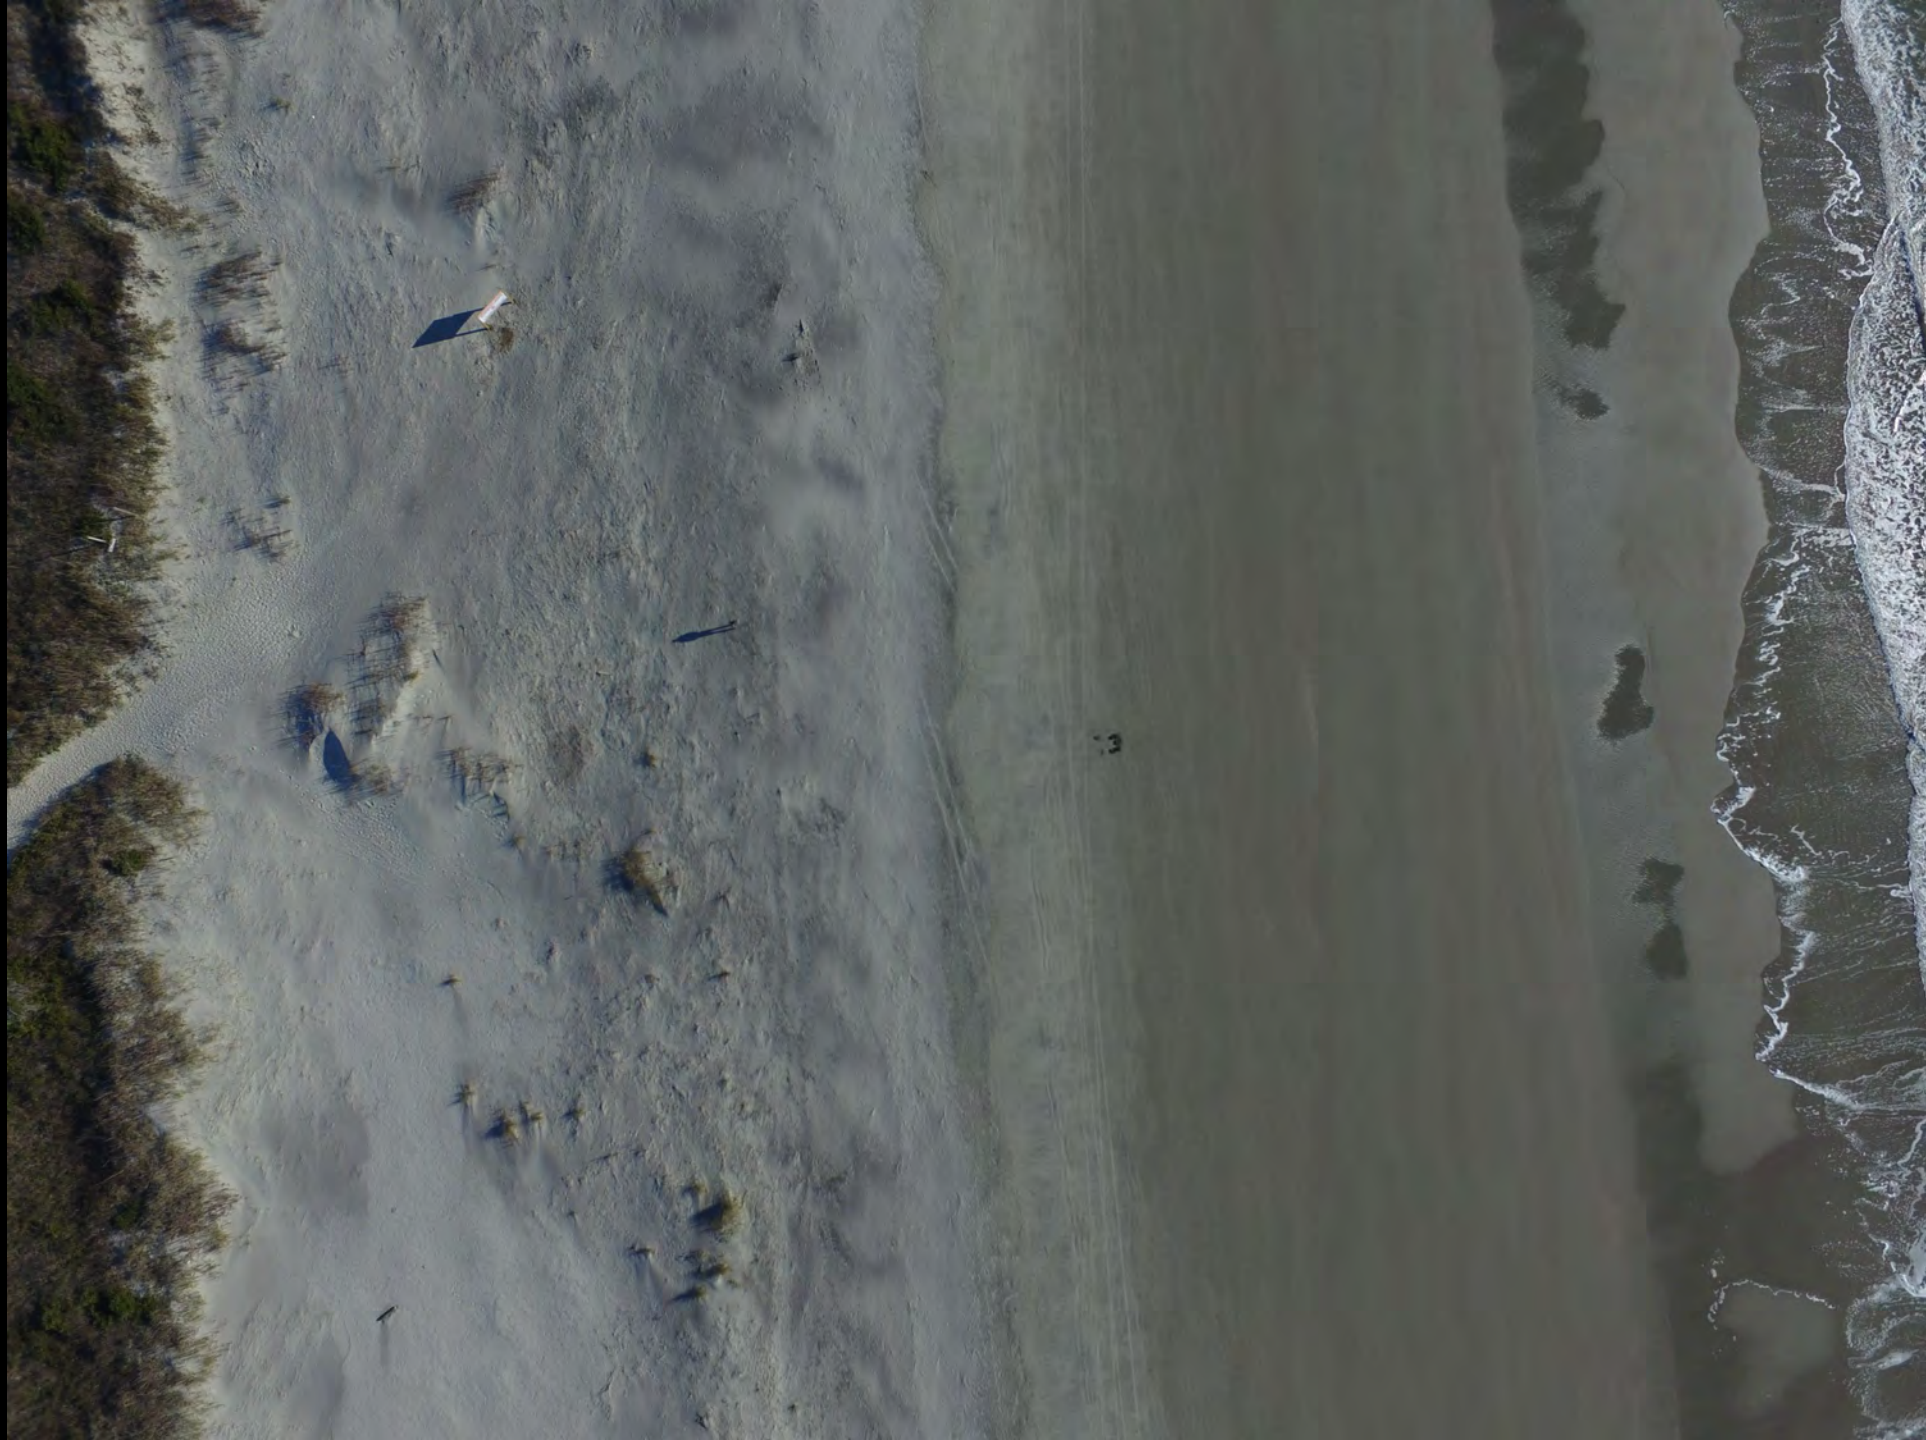
Groin 8 (Buried)

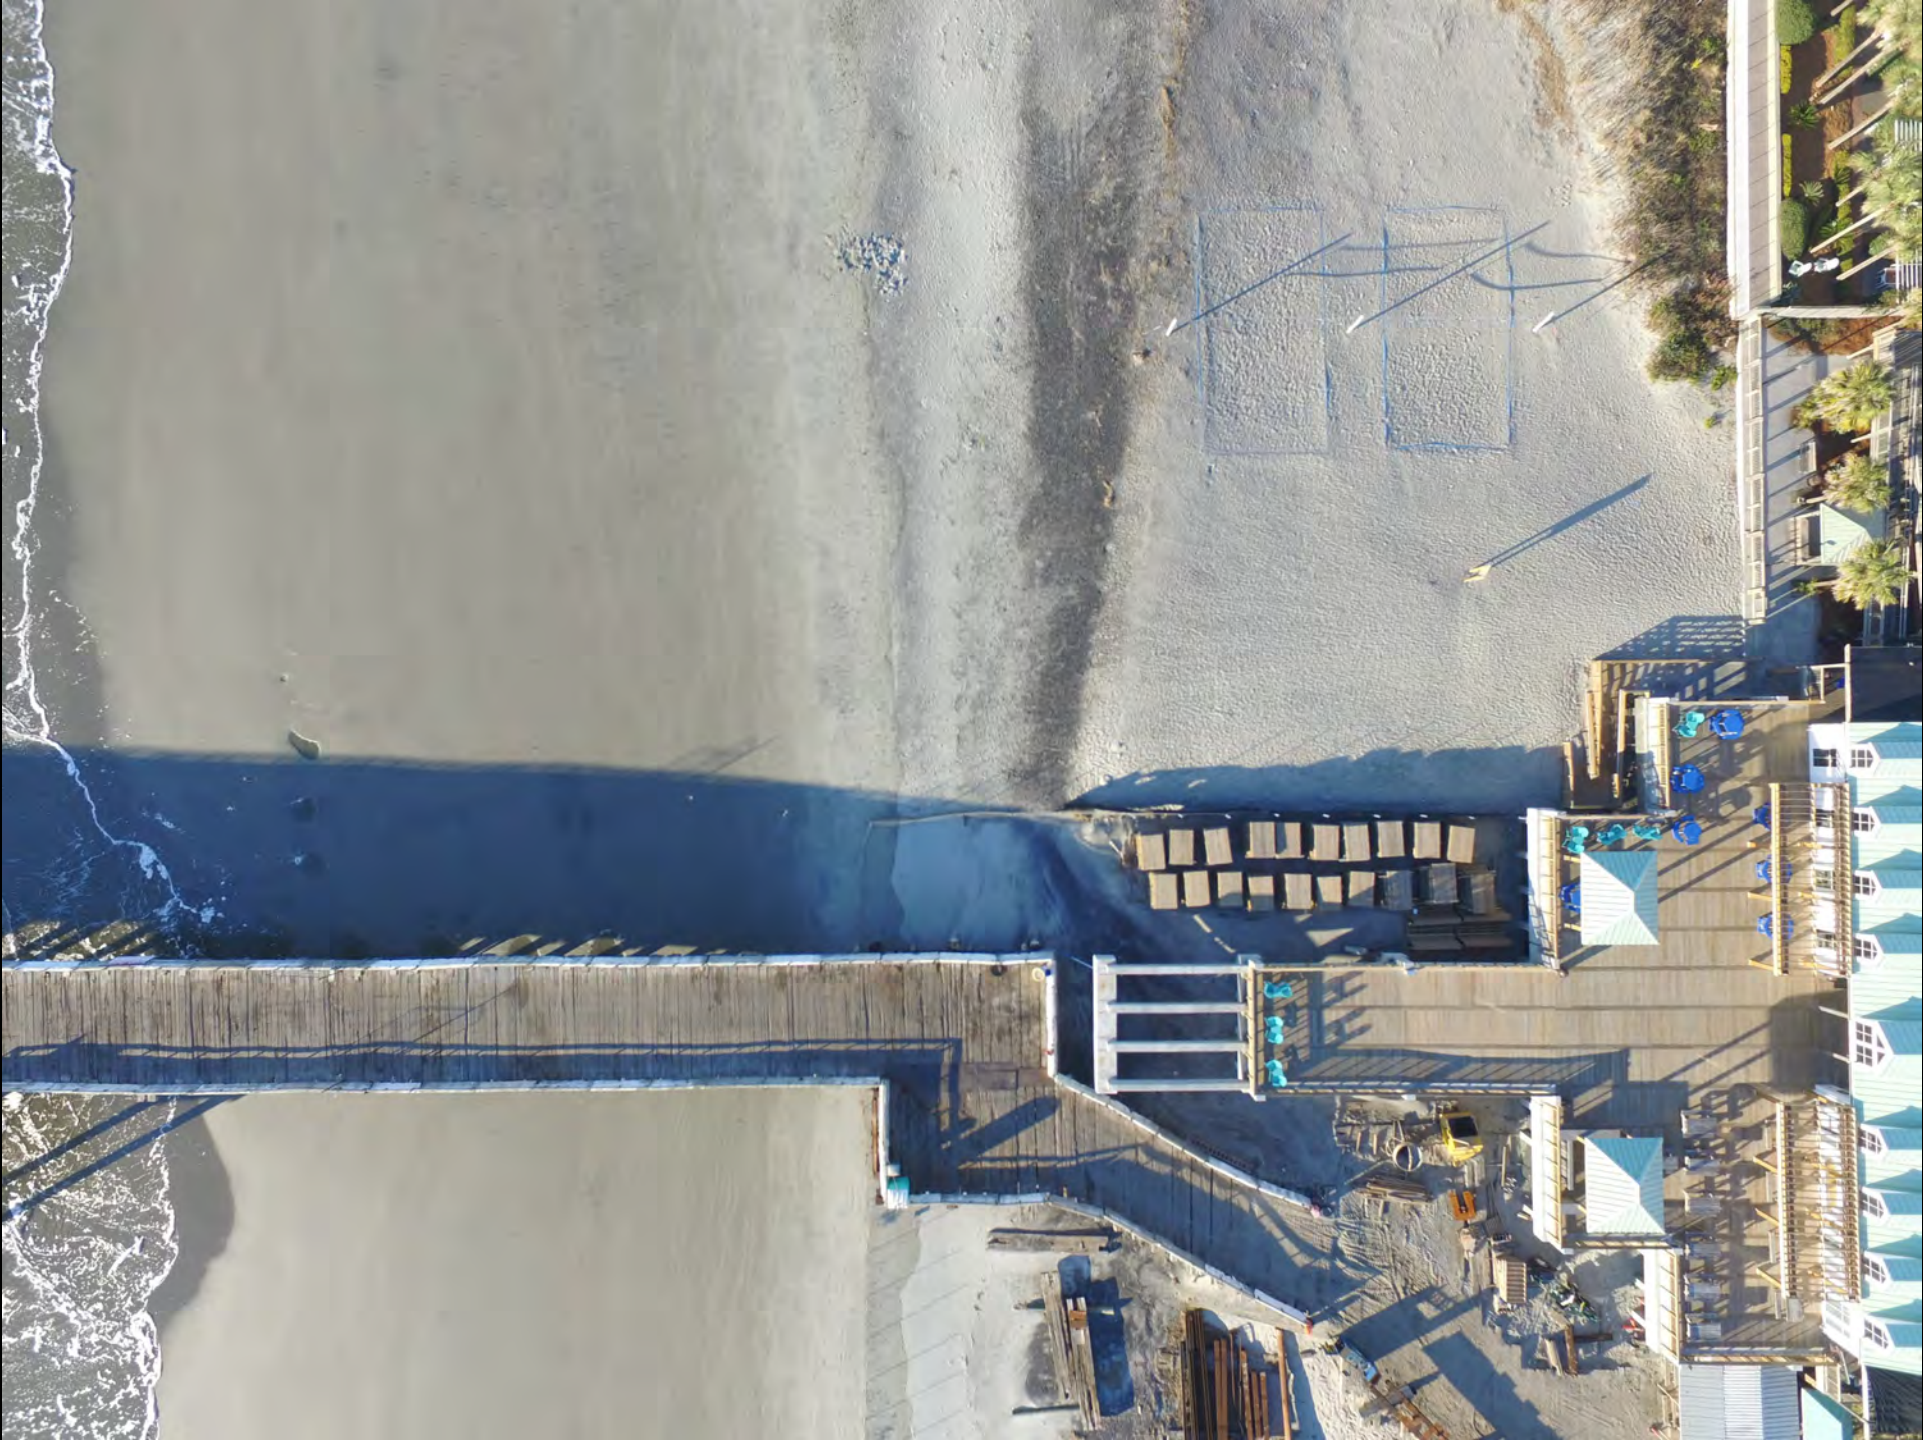
Groin 38 (Buried)
